**MARYLAND HISTORICAL TRUST
DETERMINATION OF ELIGIBILITY FORM**

Property Name: Keefer-Markell Farmstead Inventory Number: F-1-208
Address: 4944 Buckeystown Pike City: Lime Kiln Zip Code:
County: Frederick USGS Topographic Map: Buckeystown
Owner: Old Chapel Corporation C/O Chevy Chase F.S.B. Is the property being evaluated a district? ☐ yes
Tax Parcel Number: 3 Tax Map Number: 86 Tax Account ID Number: 005642
Project: Westview South Agency:
Site visit by MHT Staff: ☒ no ☐ yes Name: Date:
Is the property located within a historic district? ☐ Yes ☒ no

Continuation Sheet No. 1

F-1-208
KEEFER - MARKELL FARMSTEAD
Lime Kiln
Frederick County, Maryland
Resource Sketch Map, Keyed
Drawn By: ES, BW
May 2004

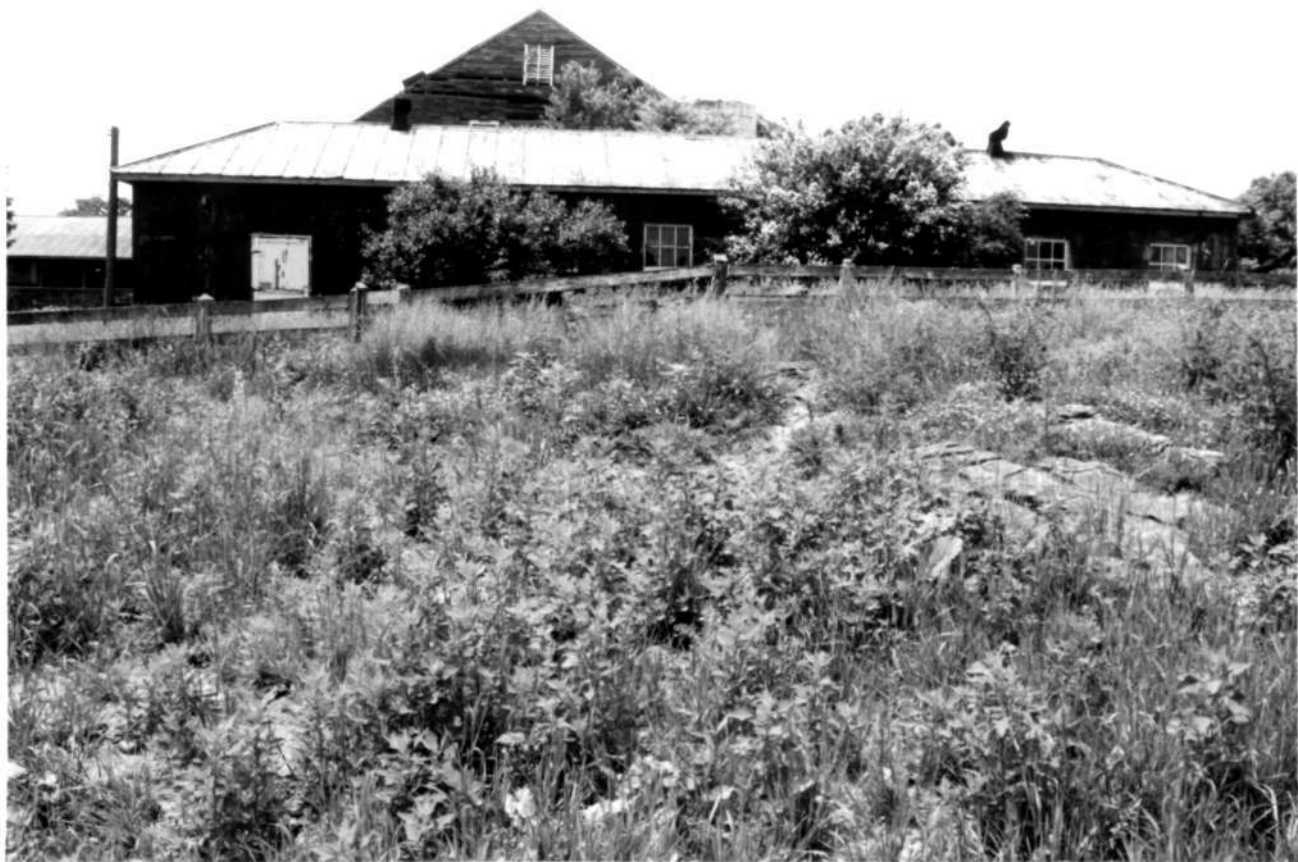
17 of 18

HILKIN PARLOR, VIEW SW

The ca. 1959 milking parlor is located northwest of the dwelling and northeast of the bank barn. The one-story building occupies a rectangular plan. A concrete block wall located on the north end of the northwest elevation connects the building to the bank barn. The concrete block building terminates in a hipped roof sheathed in standing seam metal. Three ventilators are located on the roof. The building is eight bays long and one bay wide. Seven, six-light, fixed, metal-sash windows characterize the northeast elevation. One, six-light, fixed, metal-sash window is located on the north elevation; the south elevation is blind. Four doors are found on the building; one is located on the northeast and three are located on the northwest elevation. A wood Dutch door is found on the south end of the northeast elevation. The door has one panel on each of the upper and lower sections. Two, beaded board wood doors are located on the northwest elevation, one at the north end of the building and another on the south end. A third door opening is located north of the concrete wall. The door was no longer extant. The milking parlor contains four metal stanchions and feed trough. The attached dairy is located at the north end of the building.

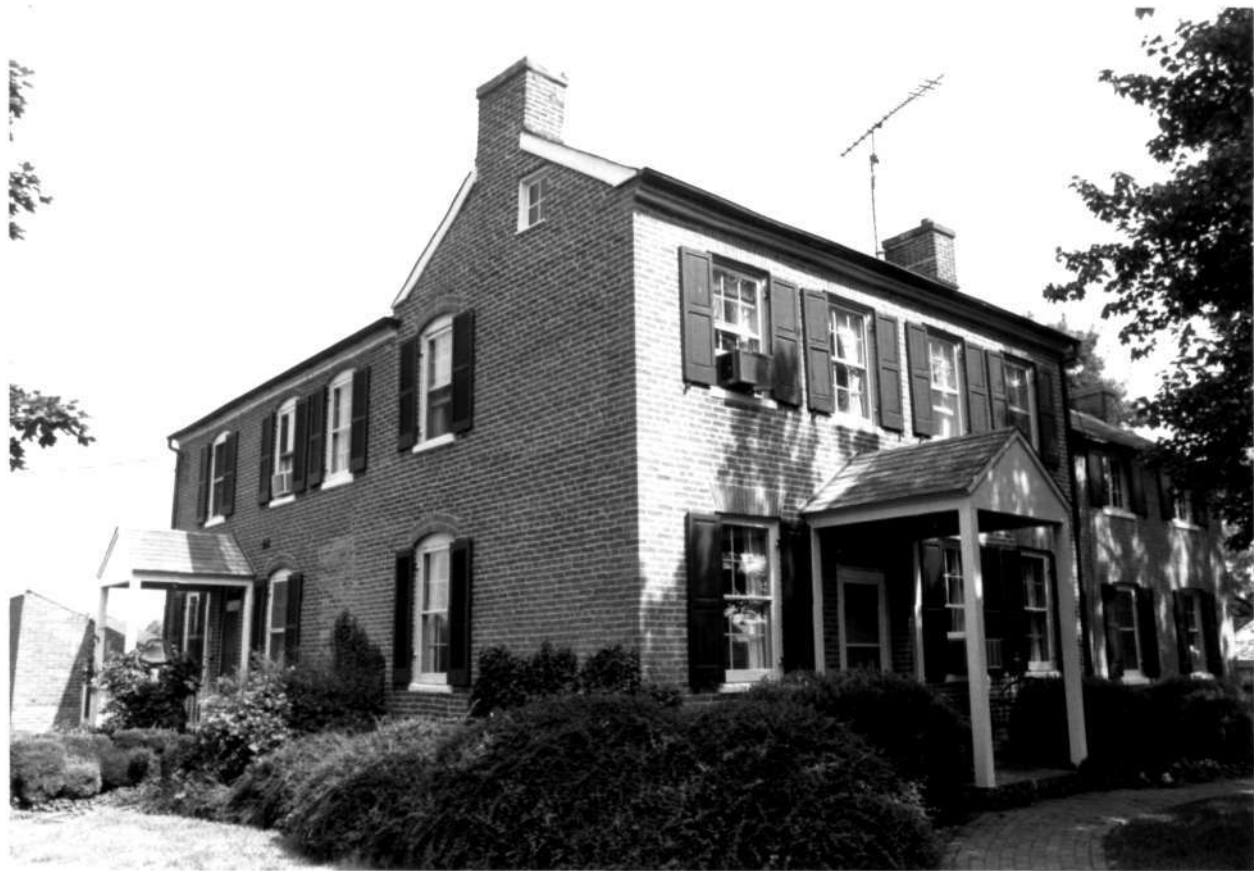
1/8

Southeast corner view

The earliest section of the house is a two-story brick structure with four bays on the east elevation. The 5:1 American bond walls have been sandblasted. The current owner, Mr. Alden Fisher, has photographs of the condition of the house in the early 1950's. Most of the deteriorated exterior features were removed, including windows and shutters. The composition roof is also a replacement of the standing seam metal roof extant in 1953. The window and door openings have gauged flat arches. The entrance is in the south inner bay and has a 1953 gable-roofed entry porch. Mr. Fisher says the deteriorated earlier porch covered the entire first story and had turned columns. The door is a 1950's replacement and a three-light transom tops the opening. The 6/6 windows are also replacements, as are the solid raised panel wood shutters. Interior end chimneys are at the north and south gable ends. The south elevation has a single off-center bay with segmental arches, a detail indicating that it was added about 1860, probably at the same time the wing was added, which has the same type of arches. The north gable end of the house is adjoined by the 1953 two-story brick addition. The rear wing extends from the southwest corner of the circa 1840 section. Although there is no clearly discernible seam between the wing and the main section, the brick is a darker color than the front section and the presence of the segmental arches indicates its later date, possibly about 1860. The sash is 6/6 and the shutters are louvred. A 1953 entry porch is over the south elevation entrance to the wing. One opening on the first story has been filled in with brick. An interior chimney rises above the roof of the wing. On the north side of the wing is a one-story enclosed porch with screens and jalousie windows added in 1953.

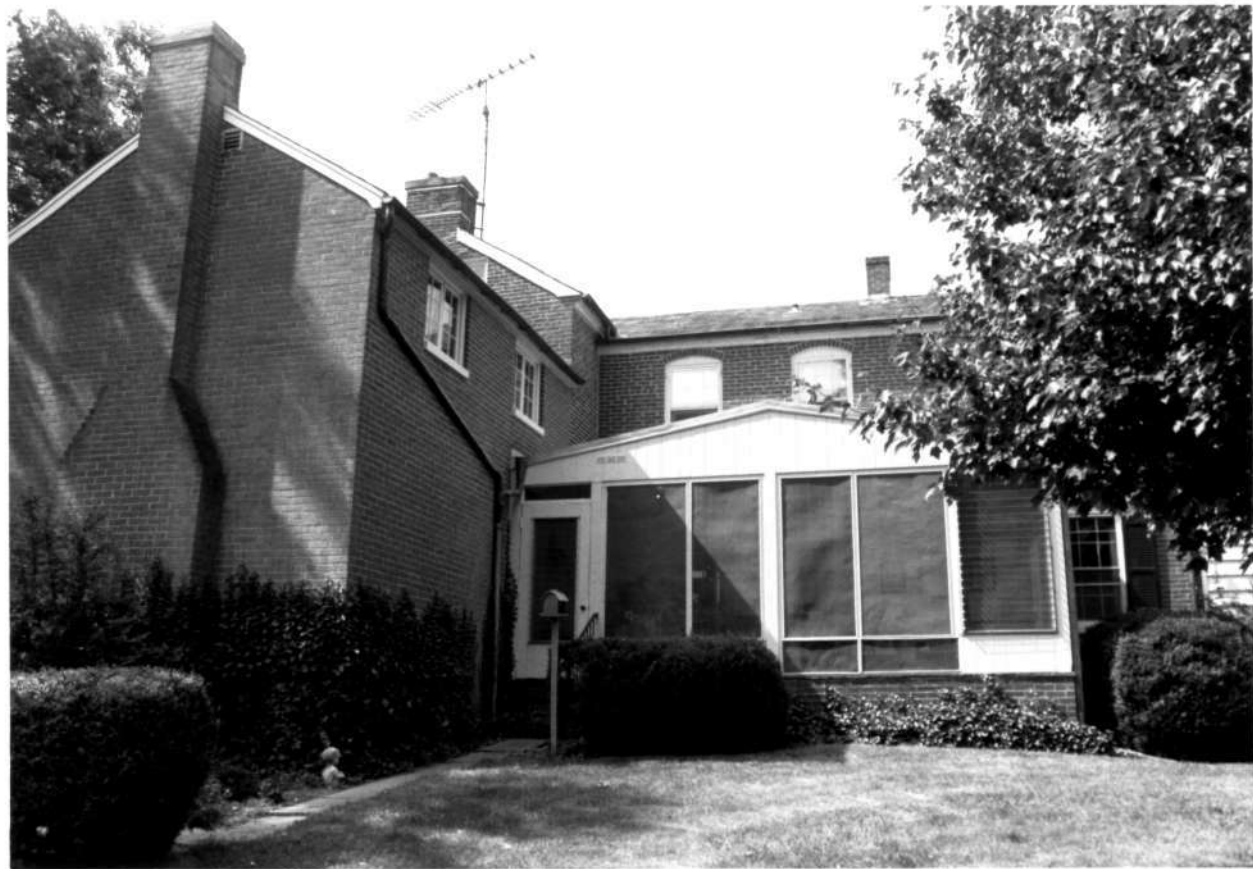
2/8

Northwest corner view

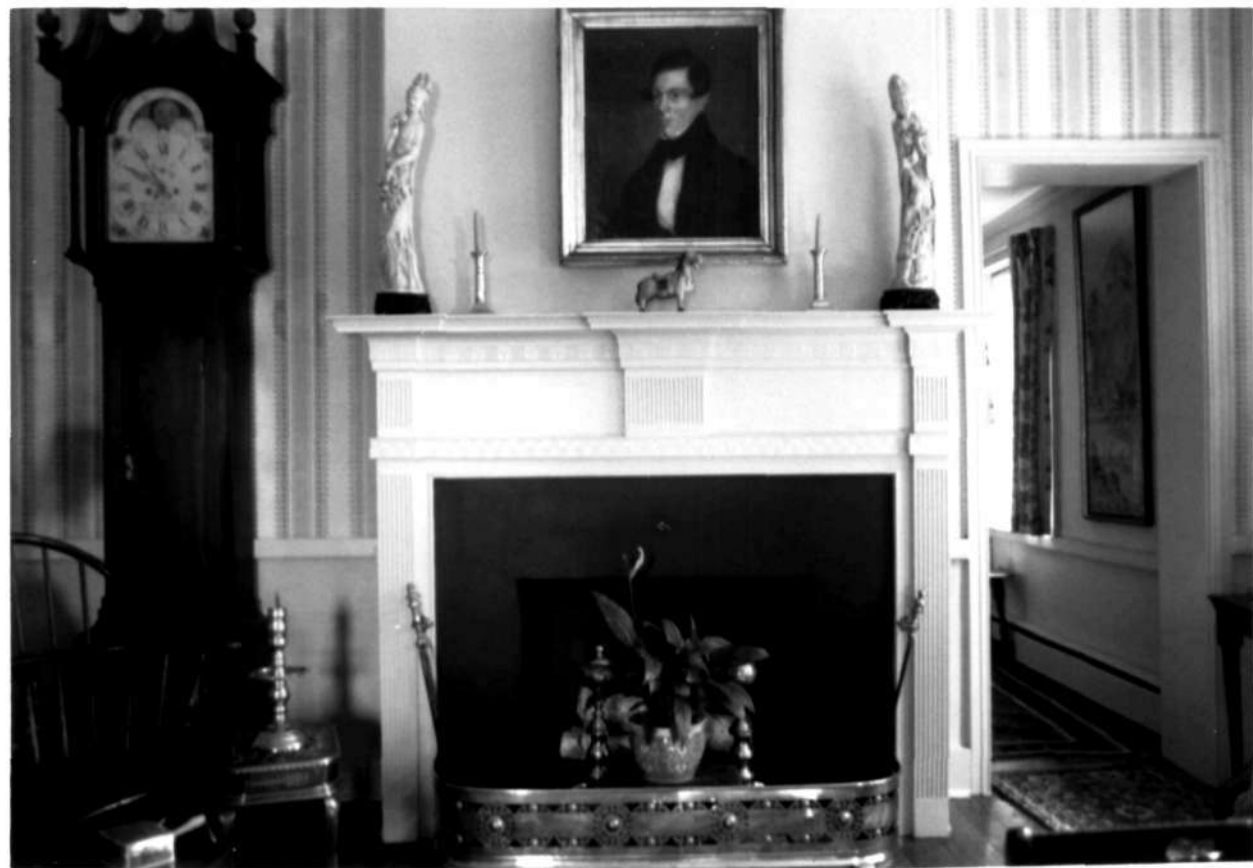
3/8

Early 19th century mantel of unknown
origin installed in 1950's

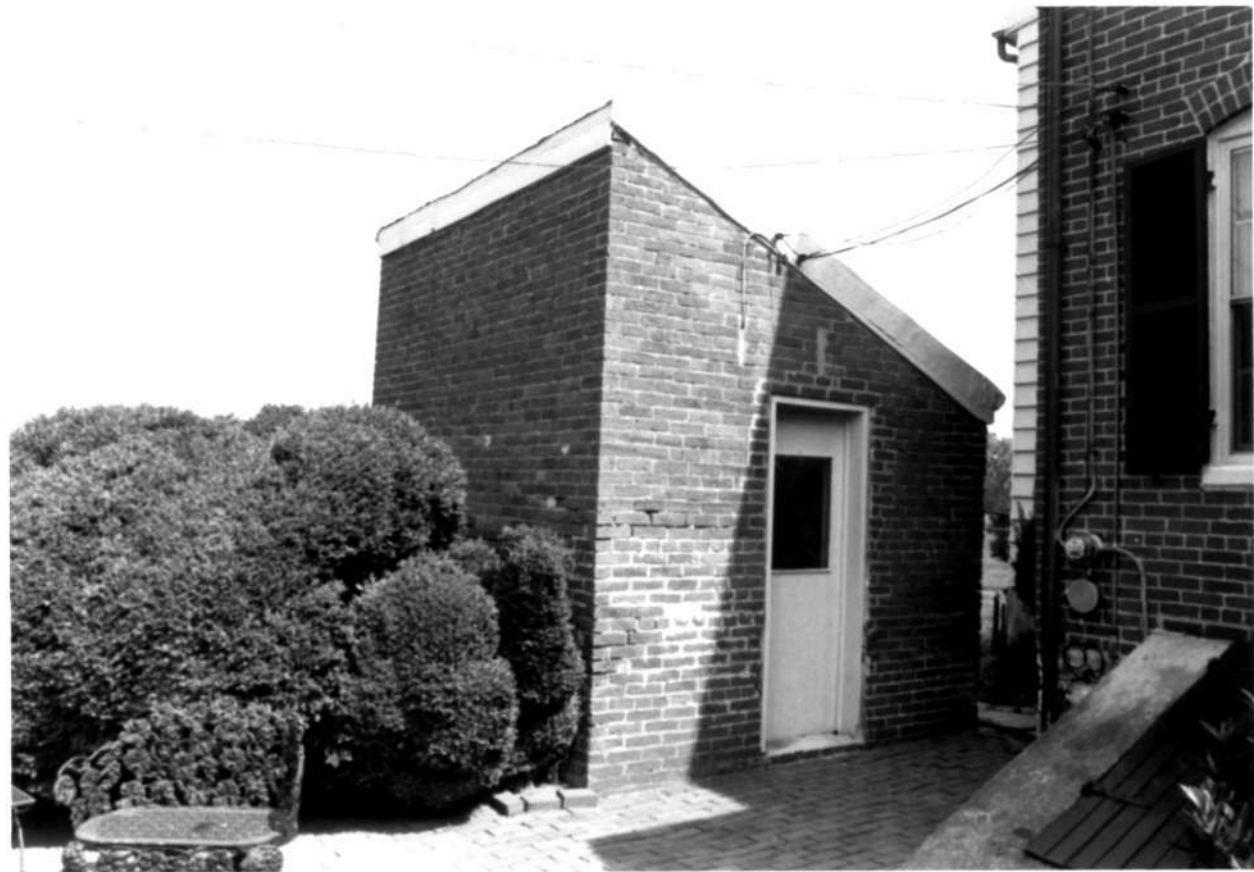
4/8

Brick outbuilding, east elevation

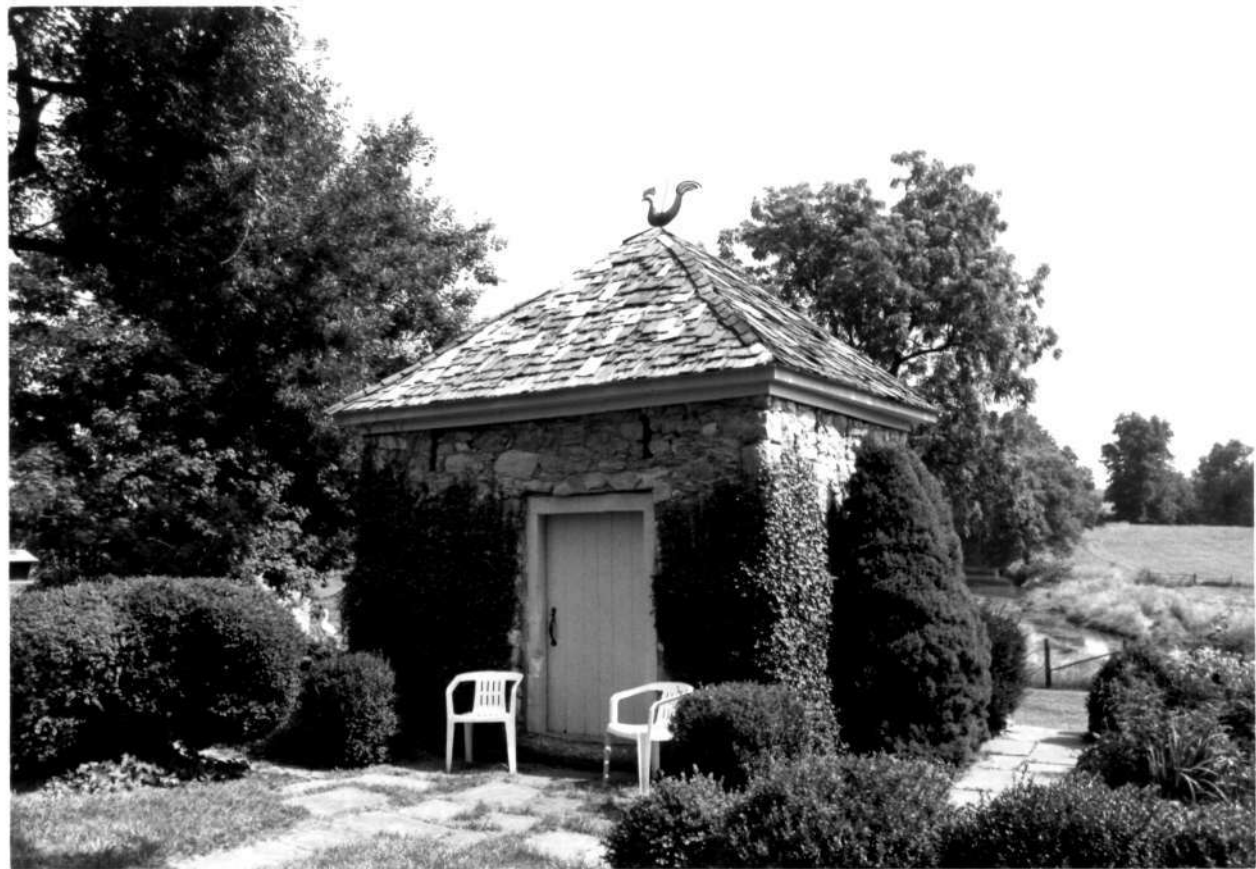
5/8

Smokehouse, southeast corner view

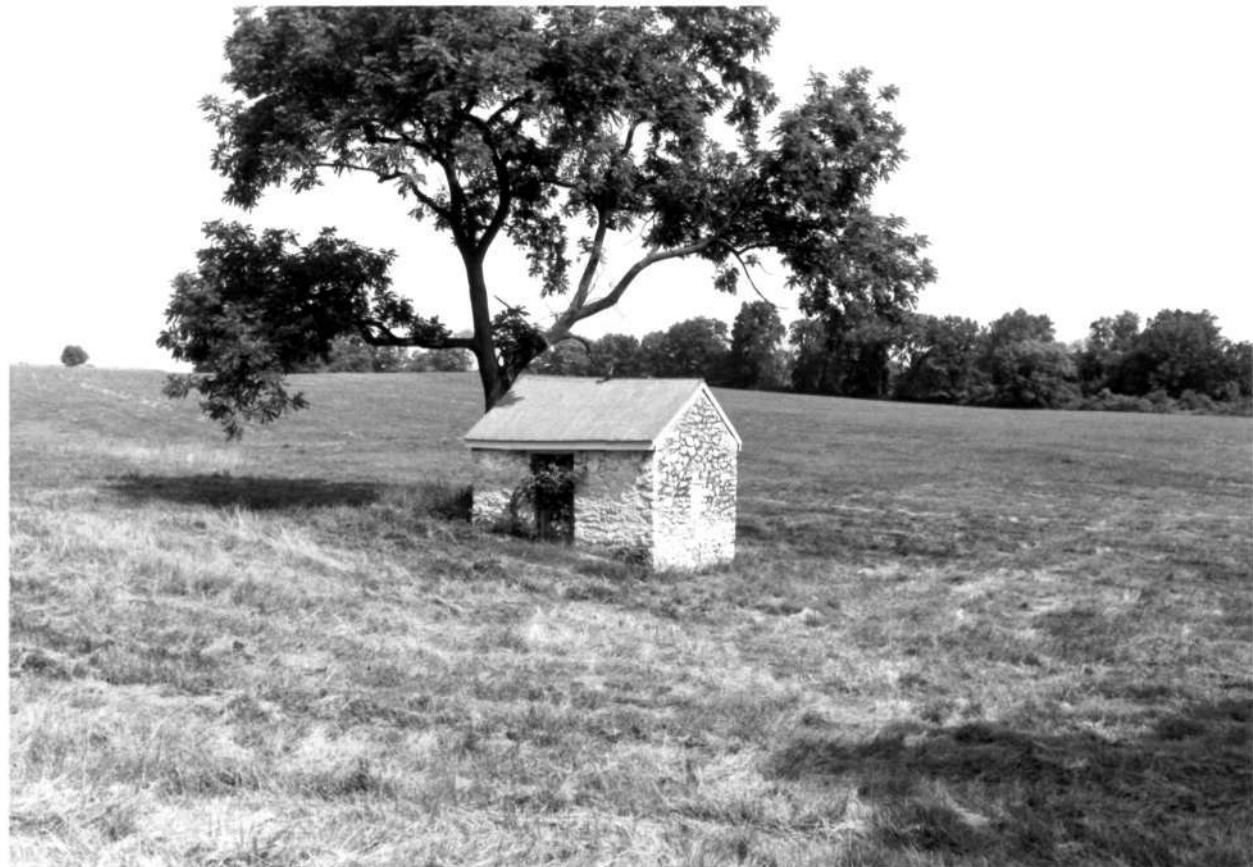
6/8 .

Neg. loc.: Md. SHPO, Crownsville, Md.
Springhouse, southeast corner view from
distance

Springhouse: The stone springhouse is located in a field northwest of the house at the base of a large tree. Although not closely observed, the building has a vertical board door on the south elevation and a corrugated metal gable roof. A boarded opening is on the northeast gable end. The interior was not observed, but similar outbuildings seen throughout Frederick County have a trough in the floor through which the spring, located either inside or just outside the foundation, flows to an escape hole on the lower side of the building. The spring does not appear to be active, as no wet ground is visible on the northeast side, where water would be expected to flow toward Ballenger Creek. The springhouse also dates from about 1840.

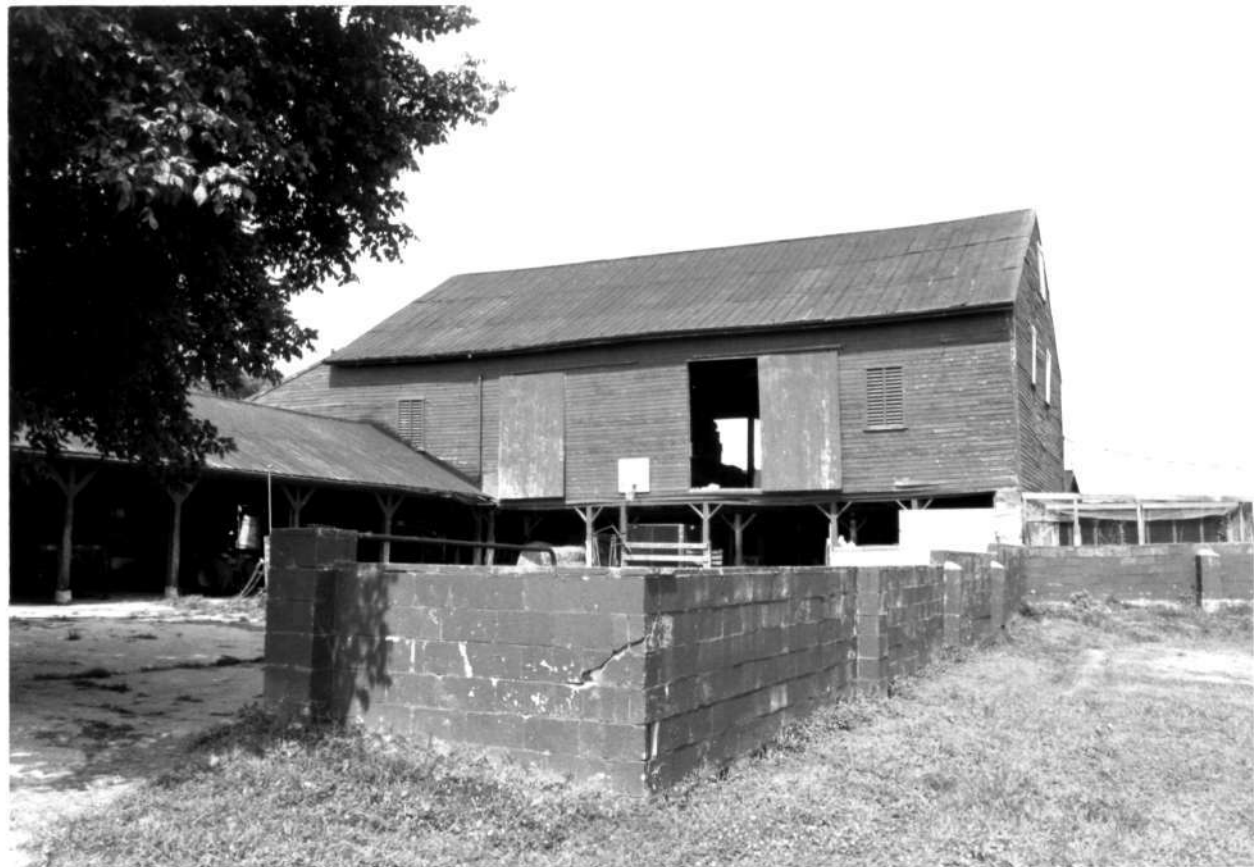
7/8

Bank born, east elevation

Bank barn and wagon shed: The bank barn is located about 100 yards southwest of the domestic group. It has a stone foundation and german siding on the upper structure. Its height is somewhat lower than the usual early or mid 19th century bank barn, which, with the german siding, indicates that it was probably built about 1900-1910. It has rectangular louvred vents and a standing seam metal roof. A non-contributing loafing shed adjoins the barn at a right angle near the southeast end of the barn. The wagon shed is located west of the barn and has vertical siding and a standing seam roof. It does not have corn cribs flanking the drive through, suggesting that it may date from the 1920's, when corn may have been stored in other structures in the farmstead.
